CAMERA INSTALLATION IN HELIO COURIER AIRCRAFT (A)

Engineering Report No. 1216  
Date 12, Oct. 1976  
Page 1 of 8

TITLE: CAMERA HOLE MODIFICATION  
\_\_\_\_\_  
\_\_\_\_\_

AIRCRAFT MFG.: HELIO AIRCRAFT CO.  
MODEL: HELIO COURIER H. 250  
REG. NO.: CF-ZWL

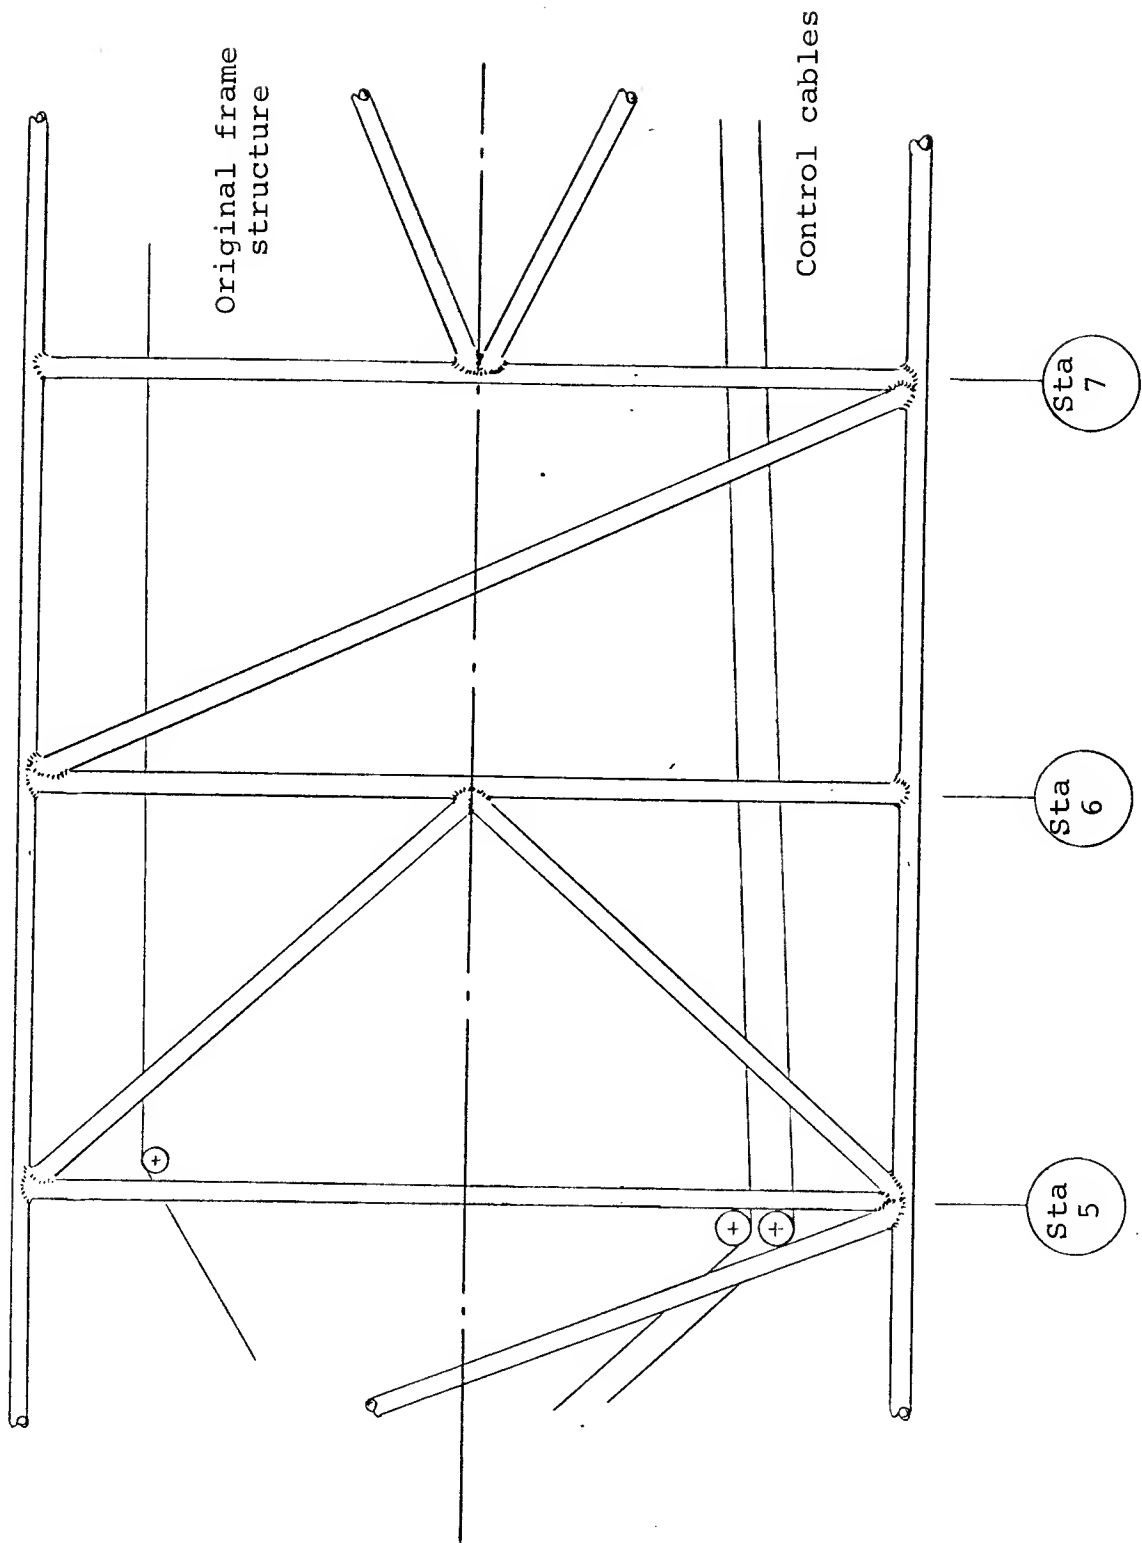
Exhibit III Original Floor Frame Structure

Two different tubings had been used in the construction of the original floor truss: 3/4 diameter X .049 wall for all diagonal braces and 7/8 dia X.049 wall for the main cross tubes. Cyril had neither size in stock back at Pembroke. A quick call to the Ministry of Transport machine shop, just next door, ensured a loan of 12' of 7/8 dia X.049 wall tubing, on the condition that replacement stock was ordered immediately. Haakon explained to Cyril that work on the aircraft was not to begin until we had thoroughly checked the new set-up and prepared a stress analysis report. However, Cyril was guaranteed of a confirmation one way or the other within twenty-four hours. Convinced that everything was ready for his planned modification, he loaded his 12' length of tube into the Helio Courier, climbed in and returned home.

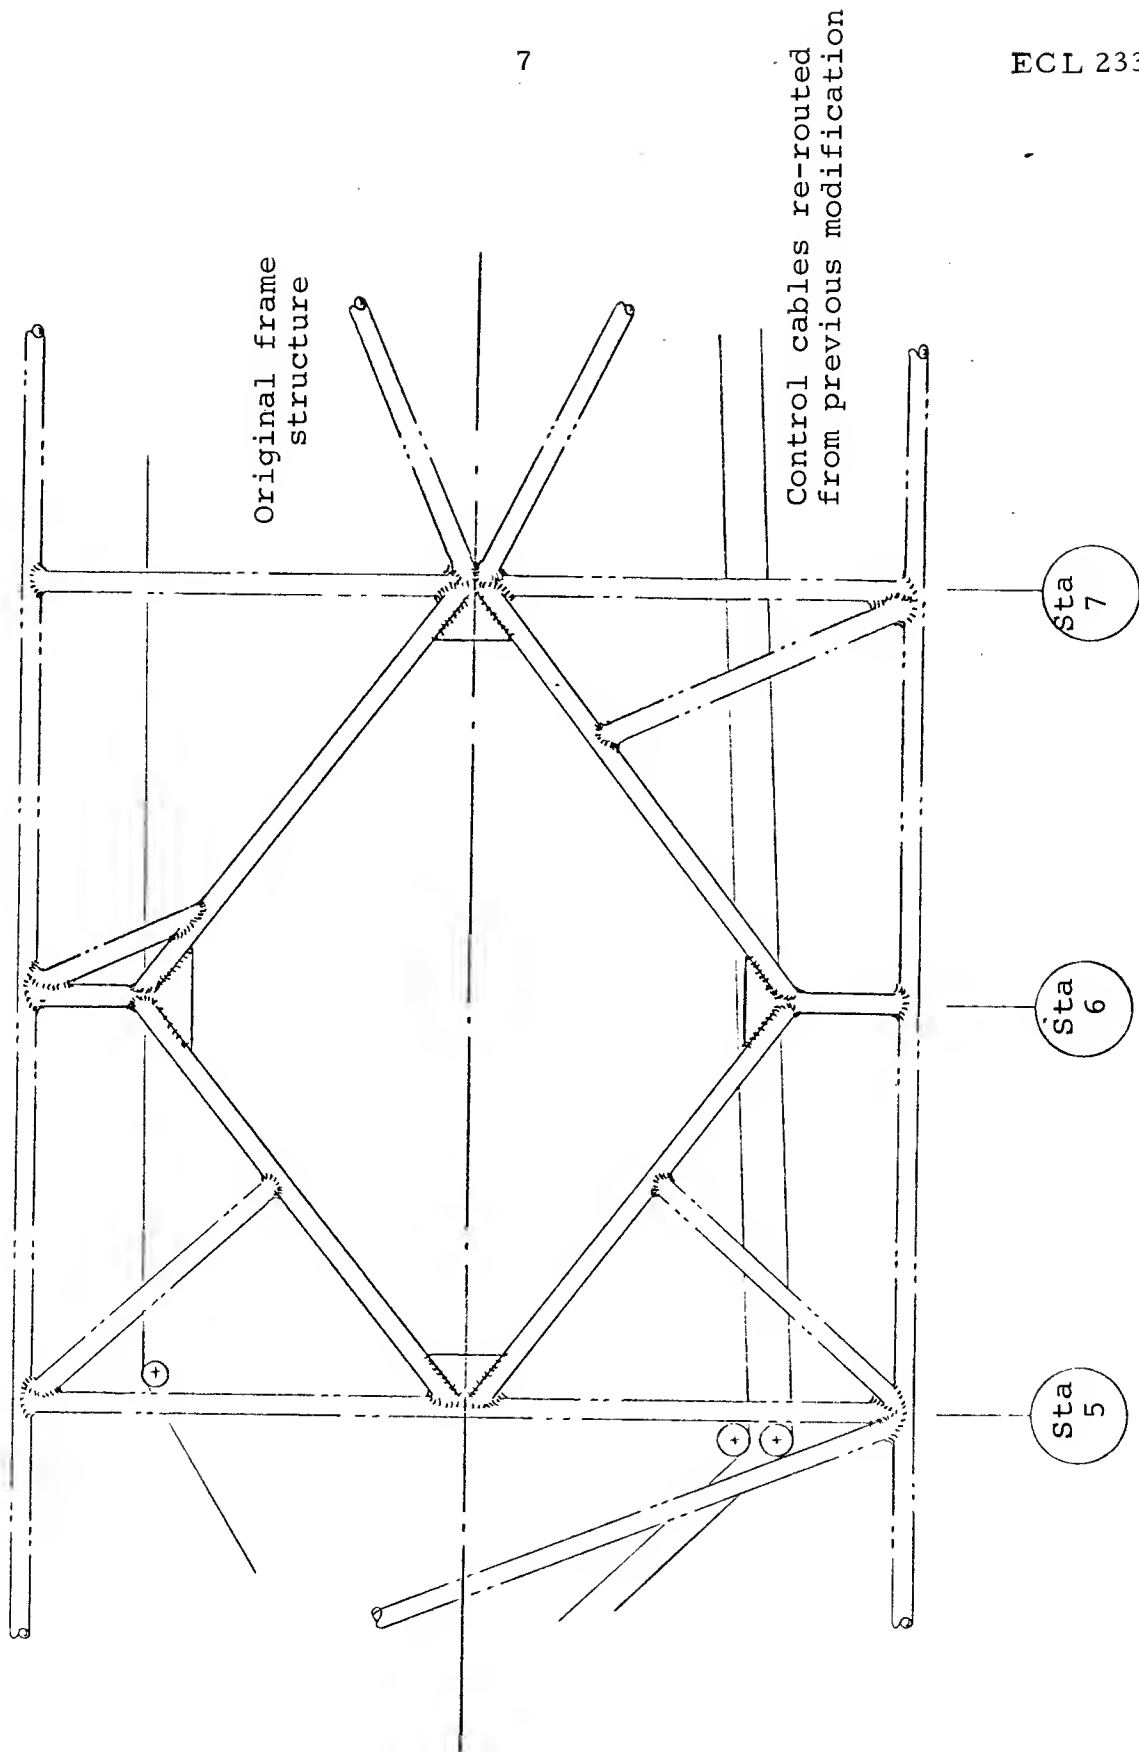
Exhibit IV Modified Floor Frame Structure

It wasn't long before Haakon and I were poking around the inside of the aircraft, trying to figure the easiest way to do the job without severely weakening the structure. Cyril stated flatly that the only sensible location for the camera was on STA 6 and right in the middle of the aircraft. (This would allow room for an operator behind the camera without crowding the pilot and copilot.) It would mean cutting four of the existing members, one of which was a critical crossfloor tubular beam. Several different configurations were considered and discussed but the easiest method and by far the

quickest was a diamond type set-up. (Exhibit IV) Cyril agreed and Haakon, after insisting that steel gussets were needed at each corner, also agreed.

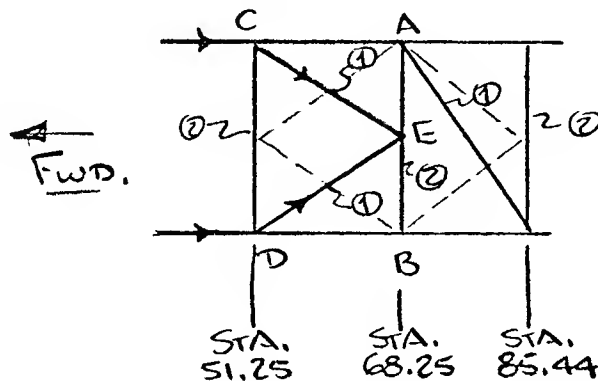
- ① SAE 4130 .75" OD  
 & .035 W.T.
- ② SAE 4130 .875" OD  
 & .049 W.T.

Look @ member CE :

$$\therefore \text{Allowable load : } 32,000 \times .07862 \approx \underline{\underline{2,500 \text{ lbs.}}}$$

this deflection is high indicating that the actual load in members CE & DE is less than the allowable of 2500 lbs. However these figures will be used for comparison purposes only. If the predicted deflections of the modified structure are equal or less than those calculated above, then the new configuration can be said to be as good as the original, or, better able to handle the loads applied to it.

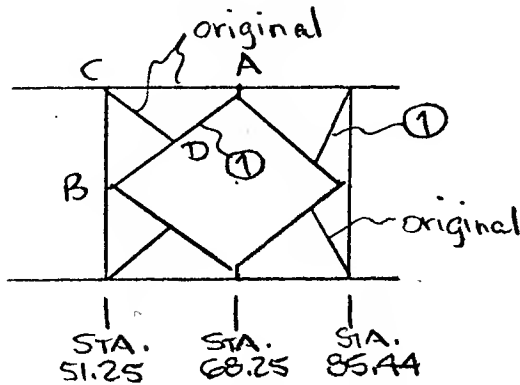
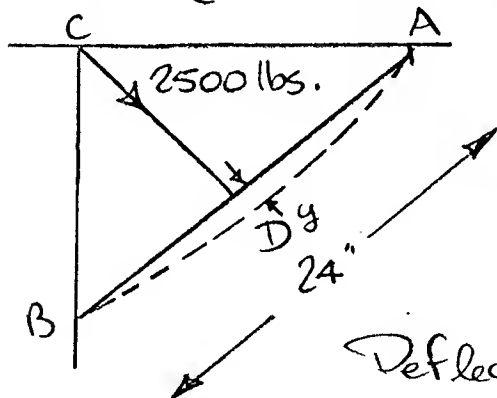
- Member CD still carries the same load as before - 2500 lbs.

$$\begin{aligned} y &= \frac{Wl^3}{192EI} \\ &= \frac{2500(24)^3}{192(30 \times 10^6)(.0109)} \\ &= 0.550 \text{ in.} \end{aligned}$$

The deflections found in the original member AB were almost  $2\frac{1}{2}$  times as high as those for the new member.

By comparison, it can be seen that the new structure is capable of handling loads similar to those encountered by the original aircraft framework. This conclusion is extremely conservative since the added effects of both the steel gussets and the  $\frac{1}{4}$ " mounting plate are ignored. The plate is fastened down with 18 #10-32 bolts & anchor nuts giving:

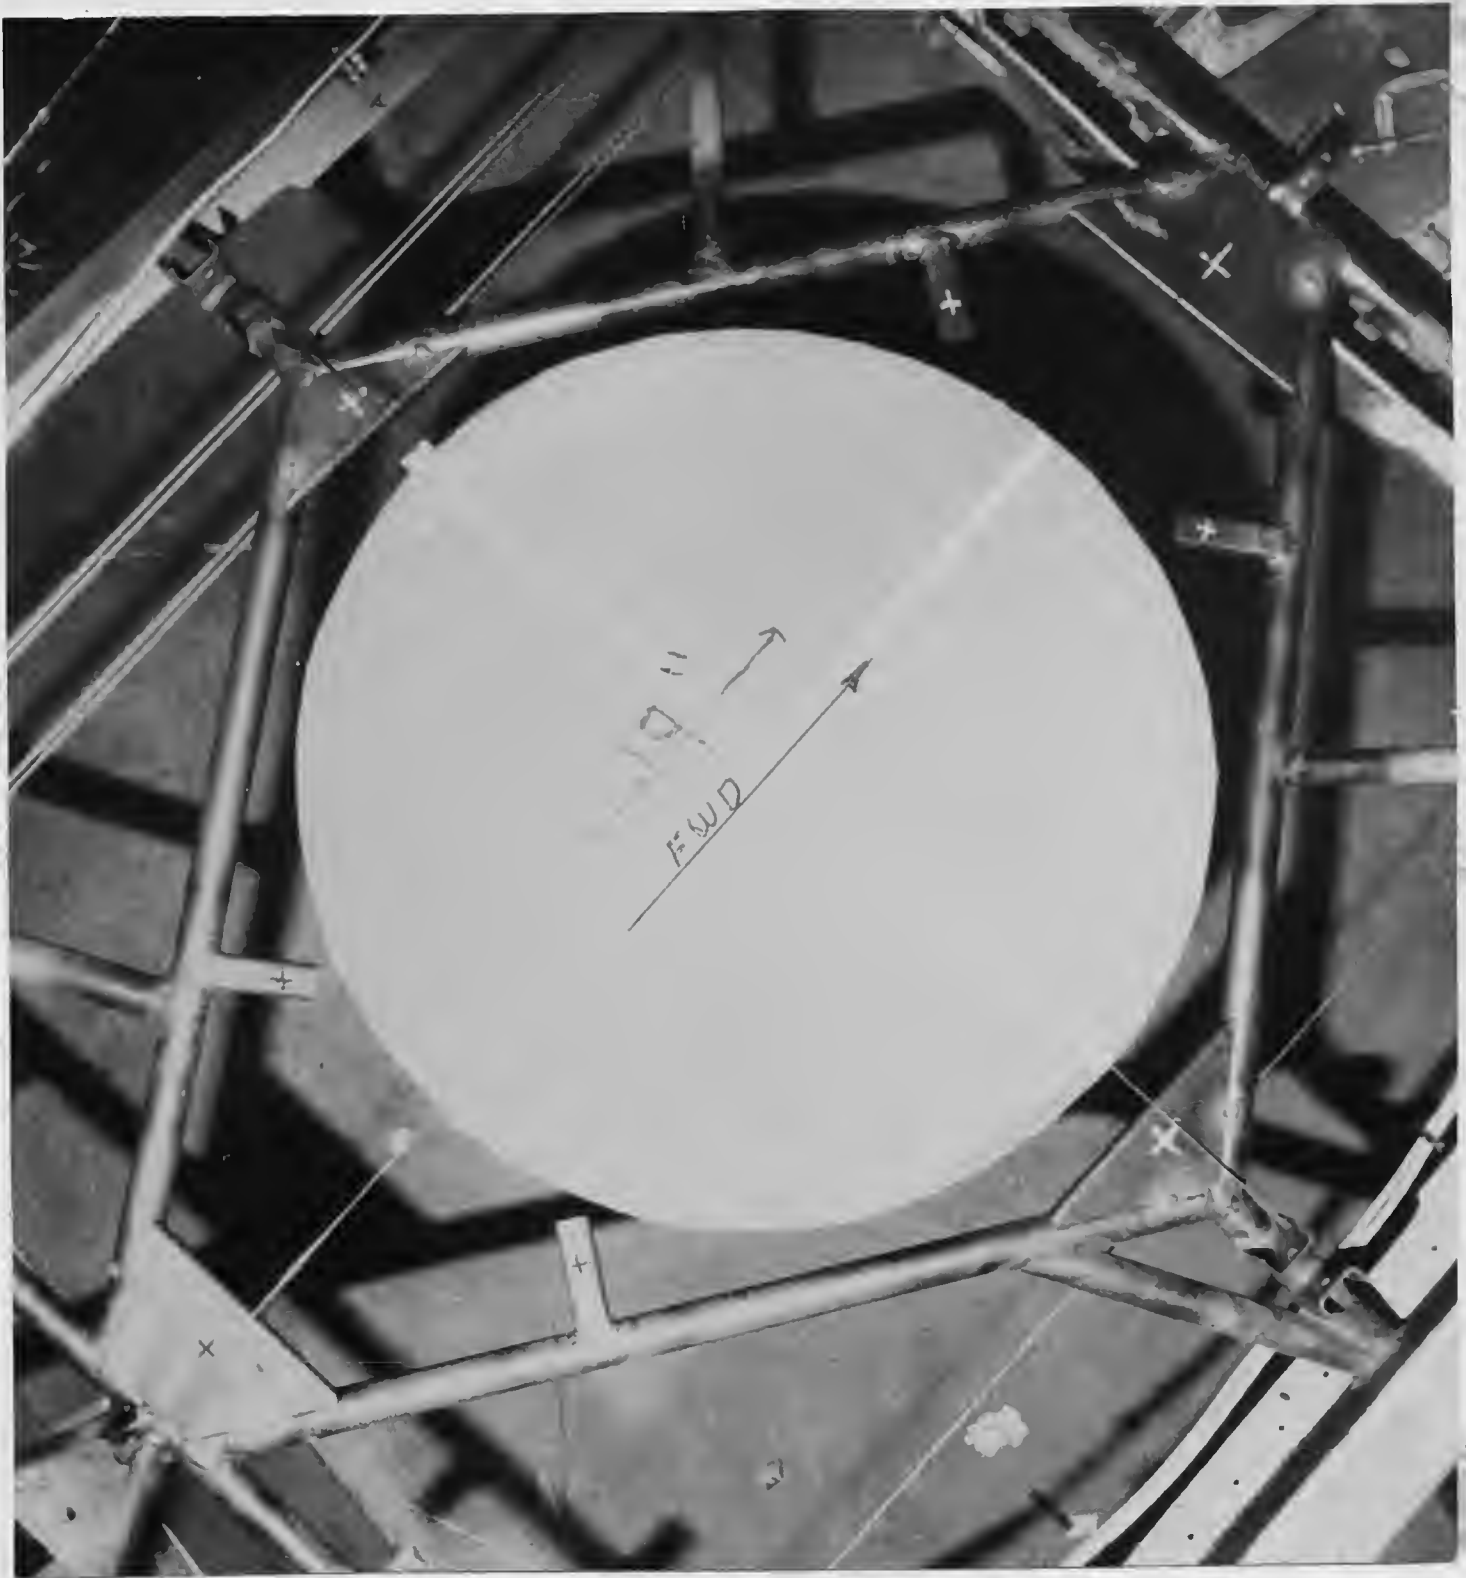
EXHIBIT V

Two weeks later, Cyril stopped by the office. He had come to "the big city" to buy some hardware supplies and brought with him two photographs of the Helio Courier's new belly floor. (Exhibit V). The photos showed not only that Cyril had followed the sketch almost to the smallest detail, but also showed the skill and workmanship that had gone into the job.
